# ES3C2 Elcometer 280 – U1915424

## Product Briefing:

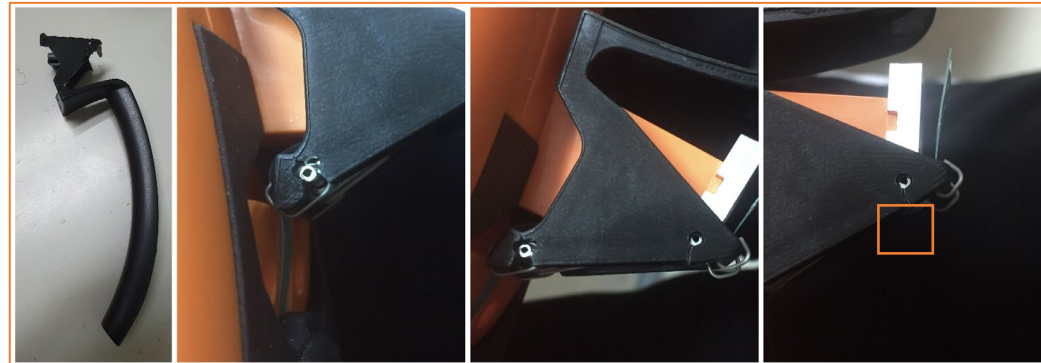
Figure 1: Paddle head fracture points

Currently most returned Elcometer 280s suffer from the same area, which is mainly the plastic paddle shown below:

The breaking of the spring holes has completely prevented the device from functioning normally, as the users' first indication is the device being unable to output high voltage, which must mean a disruption in current flow, which stems from the breaking of the bottom torsion spring accommodation leading to metal contact. Therefore, the solution for this problem would either to adjust the torsion spring in each device to avoid breaking the paddle, or to strengthen the paddle to accommodate the torsion spring at the fixing points.

**Therefore, best option is to either strengthen the weakest area or use a material with a higher yield**

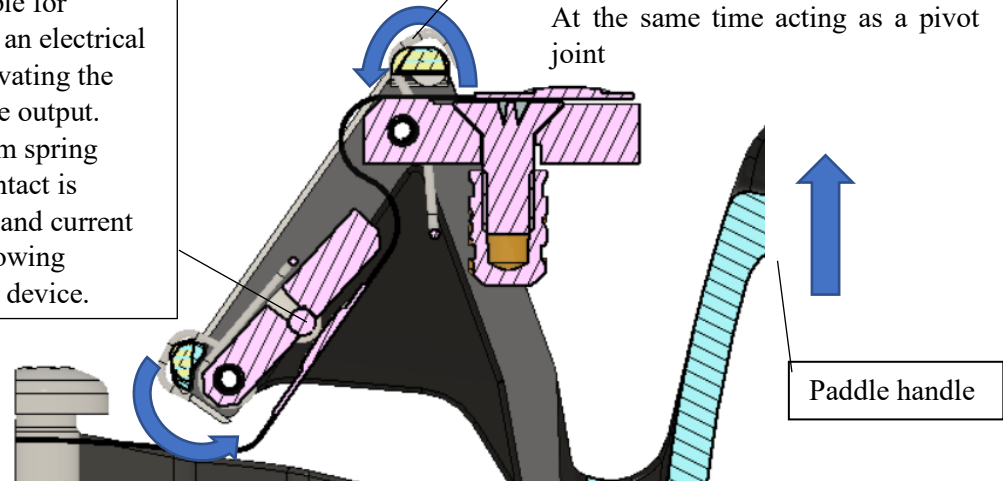
Figure 4: Section view of the button

Figure 4 shows the mechanical process causing the deformation. While the machine is working, the handle is being pulled upwards. At that moment, both spring's torsion is acting as a reaction force to the force applied at the handle. As the top and bottom is where the paddle head is housing the torsion springs, it is also where most of the load will be applied to. Once the handle is release, the springs immediately returns the paddle head to its arbitrary position to release the spring tension. Overall, these processes exert forces around the top and bottom of the paddle head. Hence Stresses around those areas will build up, which may lead to material failure, in this case, it occurred near the spring guide rod holes, leading to crack around that area.

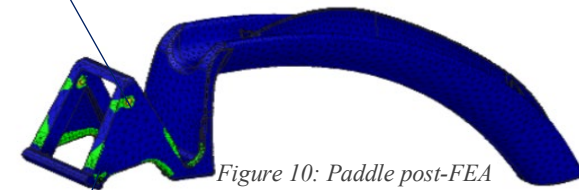
Figure 10: Paddle post-FEA

The exact fracture path was not simulated successfully at the bottom spring guide hole as the low safety factor doesn't reach the edge. However realistically, a tiny crack will propagate towards the edge.

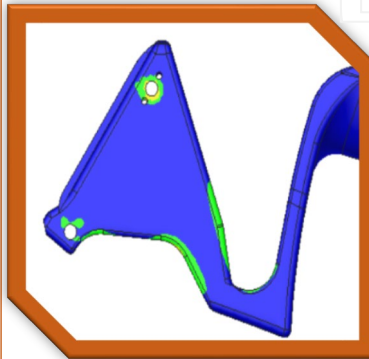
Figure 17: FEA of Design #1

Actual Minimum Safety Factor increased up to 1.28, and analysis also states that the design is marginal, which is sufficient but outside factors such as heat/cold may produce different result. Around the bottom hole area, the stresses have decreased down to 8-9 MPa from 12-11 MPa. Maximum stress has also come down to 42.67 MPa. A slight improvement just enough to prevent cracking at previous faulty areas.

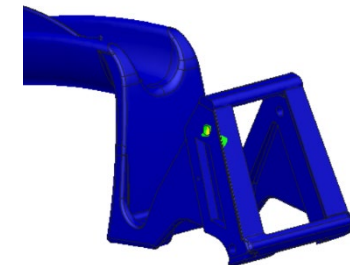
Figure 24: Final design FEA

As seen on Figure 24, for most part the safety factors have increased all the way up to 8, with the top spring guide hole having a lower safety rating of 4, which is still acceptable. Overall, the final design completely prevents fracture by providing higher yield.
