# ES3C2 Elcometer 280 – U1915424

## Product Briefing:

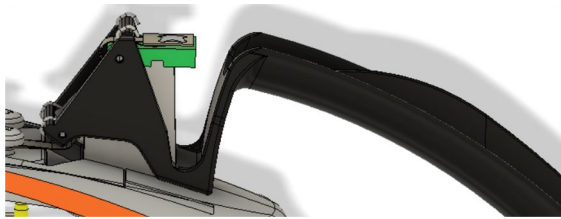
Figure 2: side view of paddle

Top Torsion Spring for keeping the handle down, allowing user to feel the activation force.

Bottom Torsion Spring for the button

Figure 4 shows the mechanical process causing the deformation. While the machine is working, the handle is being pulled upwards. At that moment, both spring's torsion is acting as a reaction force to the force applied at the handle. As the top and bottom is where the paddle head is housing the torsion springs, it is also where most of the load will be applied to. Once the handle is release, the springs immediately returns the paddle head to its arbitrary position to release the spring tension. Overall, these processes exert forces around the top and bottom of the paddle head. Hence Stresses around those areas will build up, which may lead to material failure, in this case, it occurred near the spring guide rod holes, leading to crack around that area.

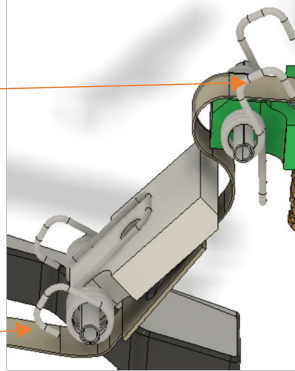
Figure 3: interior view of the button

Bottom Torsion spring is responsible for completing an electrical circuit, activating the high voltage output. Once bottom spring retracts, contact is interrupted and current will stop flowing through the device.

Top torsion spring is responsible for paddle handle's reaction force exerted against the operator's finger while pressing down on the handle. At the same time acting as a pivot joint

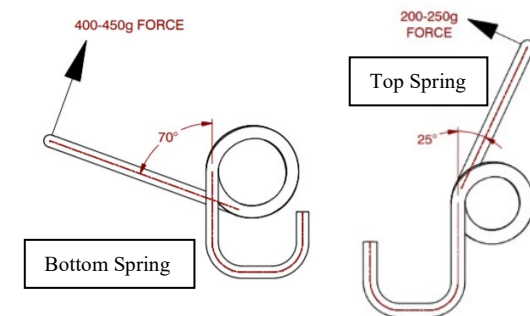
Figure 5: Spring Measurements

Moment is also accounted for from the spring, since the spring force presented in Figure 5 doesn't act on the hooks but the middle of the spring. The calculation results are listed on the next page.

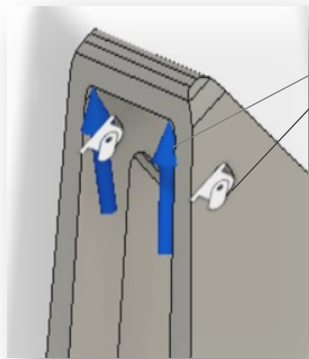
Figure 6: Paddle Head pre-FEA

force is exerted at the top of the paddle, by the hook of the torsion spring. Pin constraints are used on the holes on both sides of the paddle head and are set to have a fix tangential setting

Angled Forces are applied to where the torsion spring's hooks, the magnitudes of the forces are calculated to be 4.5N using above equation.

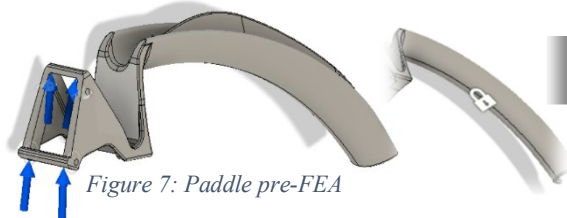
Figure 7: Paddle pre-FEA

Fixed constraint on the handle

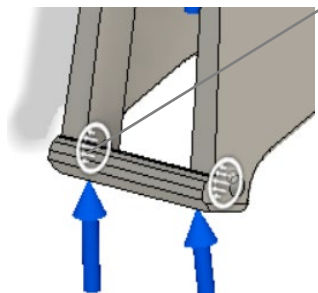
Figure 8: Paddle Head (Bottom) pre-FEA

Angled loads are again applied to the corners of the bottom rod of the paddle head, as these points is where the button torsion spring's hooks are connected to the component. The magnitude would be 9.77N and the forces are angled to replicate the positions of the force from the hooks.

Bearing load is also applied, as there is reaction force from the bottom spring guide trying to bring the paddle head back to its arbitrary position.

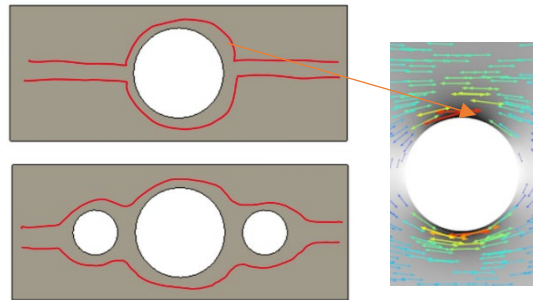
Figure 12: Internal hole stress distribution

In an object with an internal hole, the sudden redirection of stress lines also builds up stress flux. In this case, removing material may increase load-carrying capacity. This is done by adding smaller holes that are close together, as there is less redirection of stress flux.

Applying the theoretical knowledge on the left, 2 holes ( $\varnothing = 1\text{mm}$ ) with 2mm distance between the center of the circles, located on either side of the original spring guide rod hole are created. This is done to distribute the stress more uniformly around the hole to decrease peak stress, reducing chance of fracture.

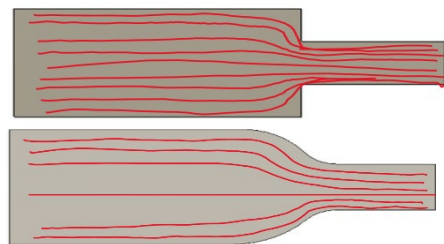
Figure 13: Corner stress comparison

As seen on the left, the top Sharp corner tends to fail due to accumulation of stress in the body from the abrupt change in geometry, seen with the crowded “Stress flow lines” at the sharp corner.

Stress reduction of corner can be seen on the front edge near the bottom guide rod hole. A 3mm radius fillet is set at the sharp edge where the bottom crack propagated at the paddle head. The fillet again allows for less stress concentrated around the location of the bottom crack.

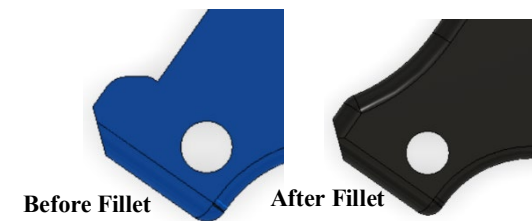
Figure 16: Comparison of edges on Design #1

The design provides a more uniform stress distribution, reducing the stress concentration at the main fracture points around the guide rod area.

Actual Minimum Safety Factor increased up to 1.28, and analysis also states that the design is marginal, which is sufficient but outside factors such as heat/cold may produce different result. Around the bottom hole area, the stresses have decreased down to 8-9 MPa from 12-11 MPa. Maximum stress has also come down to 42.67 MPa. A slight improvement just enough to prevent cracking at previous faulty areas.

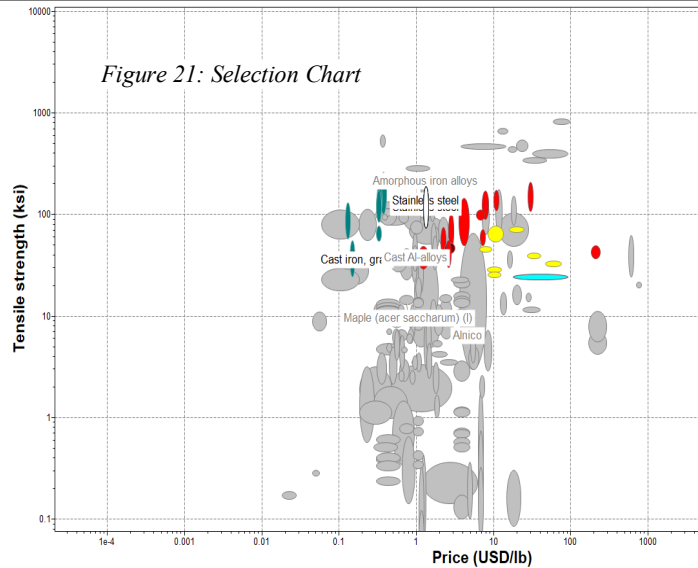
Figure 21: Selection Chart

The Grant EduPack material selector is used to pick a material for the reinforcement bracket. A selection chart plotting Price against Tensile Strength is activated, moreover a limit tool was used to filter materials, limit tool properties set:

Selected: Stainless Steel due to high tensile strength, high thermal durability, and reasonable price of 1.67 GBP/kg.
